**Arboricultural Report  
Trees at Proposed Site at  
The Grove  
Goatstown  
Dublin 14**

**January 2021**

**The Tree File Ltd  
Consulting Arborists  
Ashgrove House  
26 Foxrock Court  
Dublin 18  
D18 R2K1  
086-3819011**

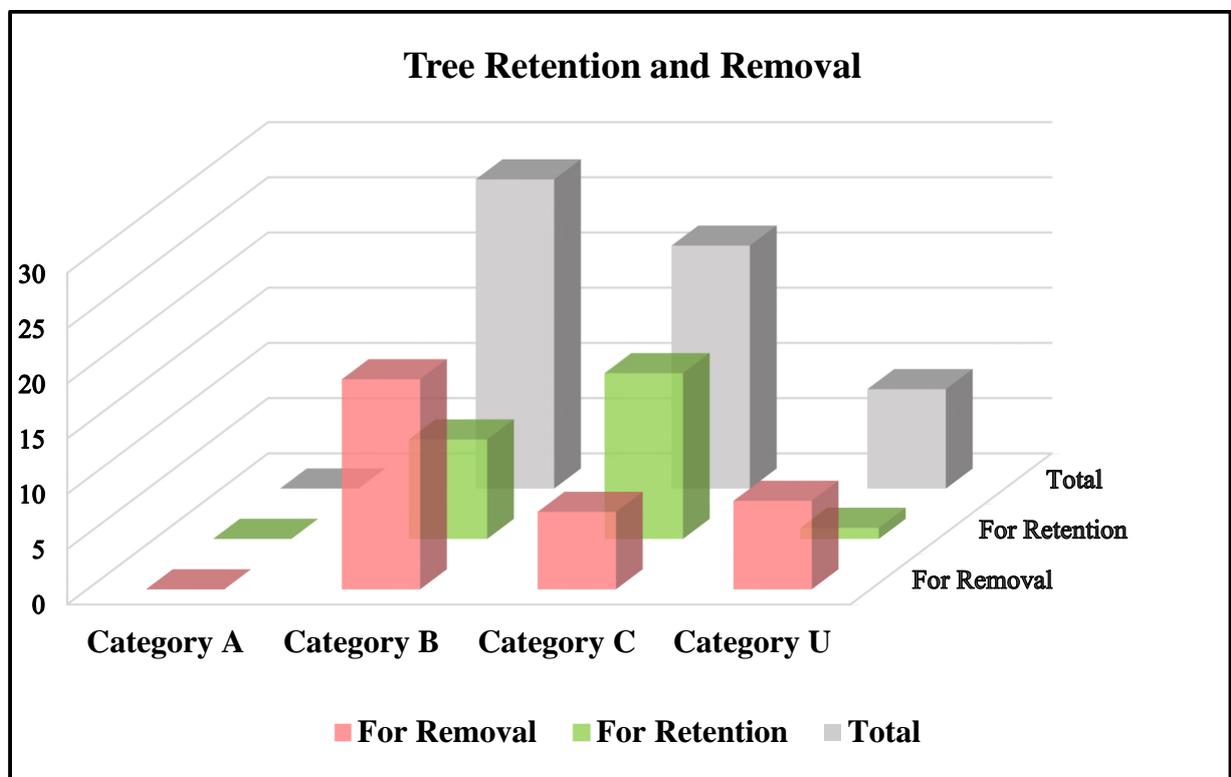
- 10.6 Of the site’s “fair” quality, category “B” trees, the development works will require the removal of tree Nos. 37 to 40, 42, 43, 46, 48, 49, 51, 53, 60 to 67 and 69.

Fig 5 Graphic Representation of Tree Loss/Retention Scenario
