**Title:           QUALITY AUDIT**  
**INCLUDING ROAD SAFETY AUDIT STAGE 1**  
**Proposed Student Accommodation (SHD), 'The Grove'**  
**Goatstown.**

**Date:          January 2021**

**Report reference: 0933R01**

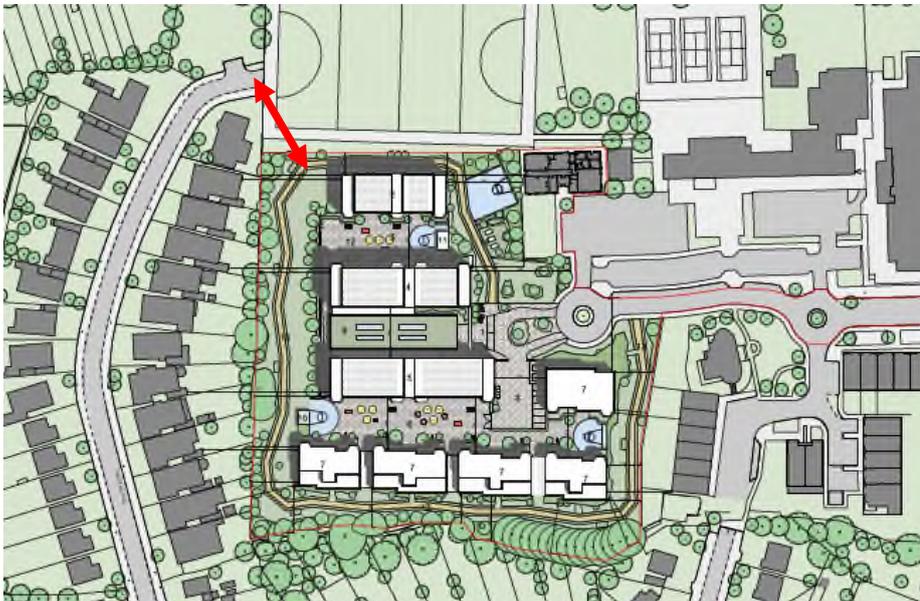
Drawing, Proposed Site Plan Stephen Marshall Urbanism Ltd.

It is not proposed to provide a pedestrian/cyclist link between the proposed development and the nearby Friarsland Road. Such a link would allow for greater accessibility for vulnerable road users to nearby amenities (e.g. Rosemount Green or the Luas Green Line stops) without having excessive journey times and having to travel on busier arterial routes.

It is recommended that a pedestrian/cyclist link be provided to Friarsland Road.

3.1	YES	NO	A pedestrian / cycle link is proposed to the north west corner of the site to facilitate a potential future connection through adjoining lands to Friarsland Road. The adjoining lands are outside the control of the applicant. However, the applicant is happy to engage with the adjacent school to facilitate the link.	Yes

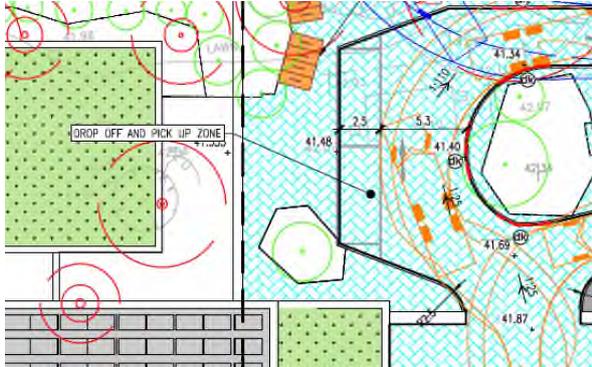
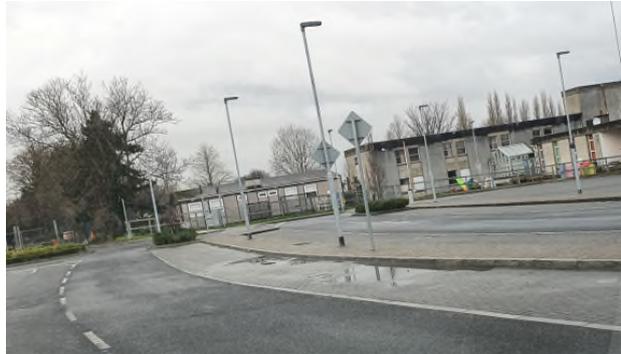
Drawing 200012-DBFL-RD-SP-DR-C-1001 P02, Roads Layout.

There are two set down spaces provided at the main access point. There is a risk that given the high capacity of the accommodation that there will not be enough space for drop off and collection and that vehicles may park in the spaces reserved for parents at the school. This could lead to safety issues for school goers as they mix with traffic associated with the development whose drivers may not be aware of local rules with regard to pick up and drop off of children etc.

It is recommended that additional drop/off set down space be made available within the development.

3.2	YES	YES	An additional drop off / set down space is proposed on the main access road to the development.	
3.3	NO	NO	Given the nature of the development, staff will include a permanent maintenance person and external maintenance will only be in exceptional circumstances. In accordance with the mobility management plan, staff will be encouraged to use sustainable modes of transport. All parking spaces will be booked through the facility and should scheduled maintenance visitors require parking, that can be accommodated.	Yes

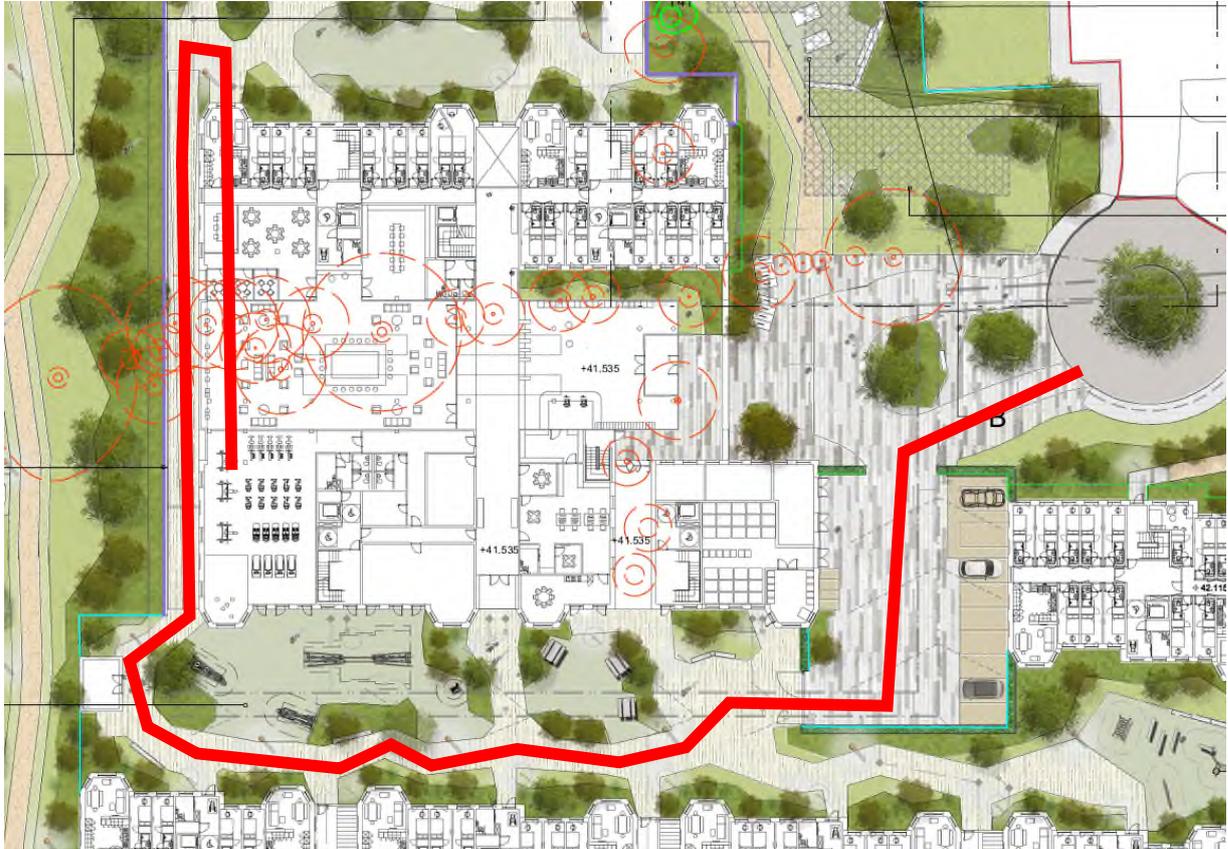
Drawing 1522-300 Rev 9, TBS

There is a long and arduous route for cyclists to enter /exit the main bicycle parking area in the lower ground including a journey through the recreational area and along the ramp at the western side of the main block. There is a risk that cyclists will abandon their bicycles outside in more convenient areas where they may be hazards for cyclists.

It is recommended that a more direct route to the bicycle parking be provided for cyclists.

3.4	NO	NO	The development is a fully managed facility and residents will not be permitted to leave bikes in unauthorised locations.	Yes

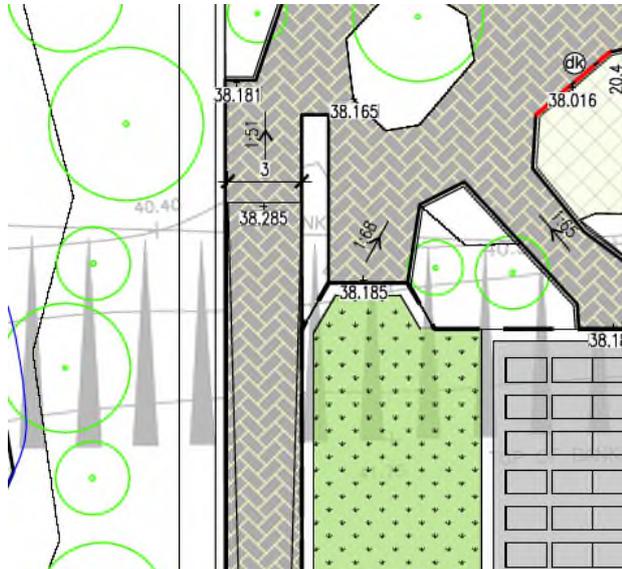
Drawing 200012-DBFL-RD-SP-DR-C-1001 P02, Roads Layout.

There ramp for cyclists and pedestrians to the west of the main block is proposed to be 3.0m wide. The effective width will be less given that there will be walls on both sides. The usage of this ramp is expected to be high given it is on the route to/from the main bicycle parking area and it links with the recreational area. The relatively narrow width could lead to collisions between cyclists and pedestrians particularly when cyclists are travelling downhill.

It is recommended that the ramp be widened to comfortably accommodate the proposed usage by both pedestrian and cyclists or that separate facilities be provided for cyclists.

Paragraph No. in Quality Audit Report	Problem accepted (yes/no)	Recommended measure accepted (yes/no)	Alternative measures (describe)	Alternative measures accepted by Auditors (Yes/No)
3.5	YES	NO	Cyclists will be requested to dismount and walk the bikes down / up the ramp.	Yes
3.6	YES	YES		
3.7	YES	YES

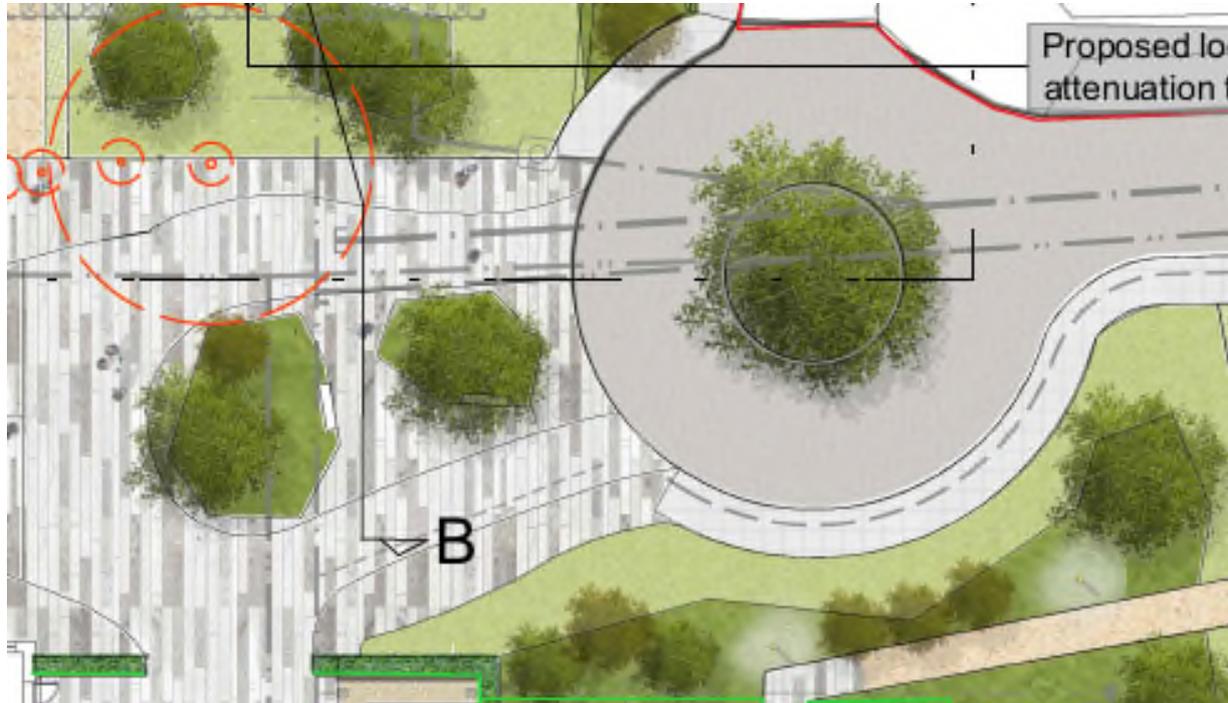
Drawing 1522-300 Rev 9, TBS

It is proposed to provide a separate access and egress from the roundabout to the development (almost like a second roundabout/gyratory) that will be a shared space for drivers and vulnerable road users. These users must be made aware that they are entering a roundabout and have to give way to traffic on their right. The roundabout will be busy during school term. There is also a proposal to have overhanging trees planted within the central island of the roundabout which may alter drivers perception of the roundabout and also change their usual driving line to avoid the branches.

It is recommended that the roundabout be treated as a public road roundabout in compliance with the Traffic Signs Manual. The entry and exit from the development should be clearly defined to avoid head-on collisions. In addition, any planting in the central island should not be a hazard with regard to visibility or obstruction.

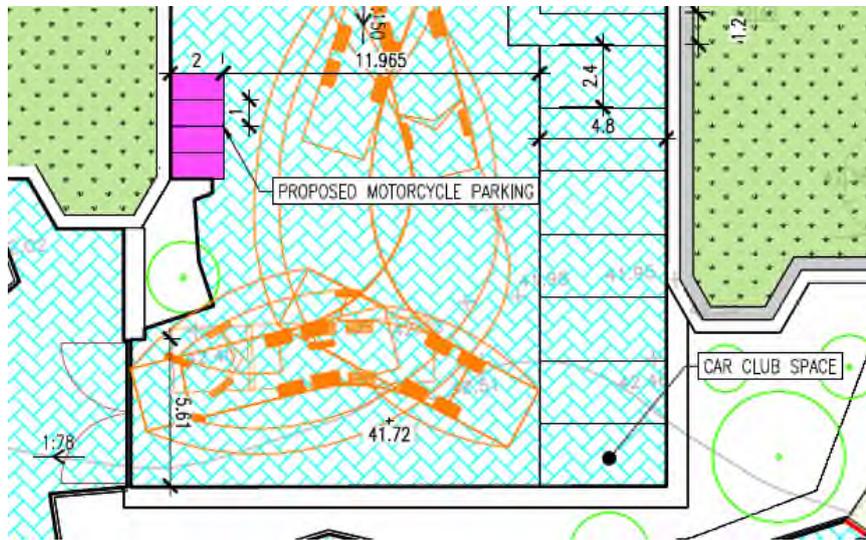
Drawing 200012-DBFL-RD-SP-DR-C-1001 P02, Roads Layout.

The swept path for the refuse vehicle is shown on the drawing. It is unclear however where the bins will be stored on collection day. There is a risk that bins may be left where they block pedestrian or cyclist routes.

It is recommended that the temporary bin storage areas be shown on the drawings so that they can be assessed for safety and accessibility.
